# MARINER VENUS / MERCURY 1973 STATUS BULLETIN

**MARINER 10's Mercury II  
Encounter Successful -  
Now Enroute to Mercury III**

23 SEPTEMBER 1974  
**BULLETIN NO. 36**

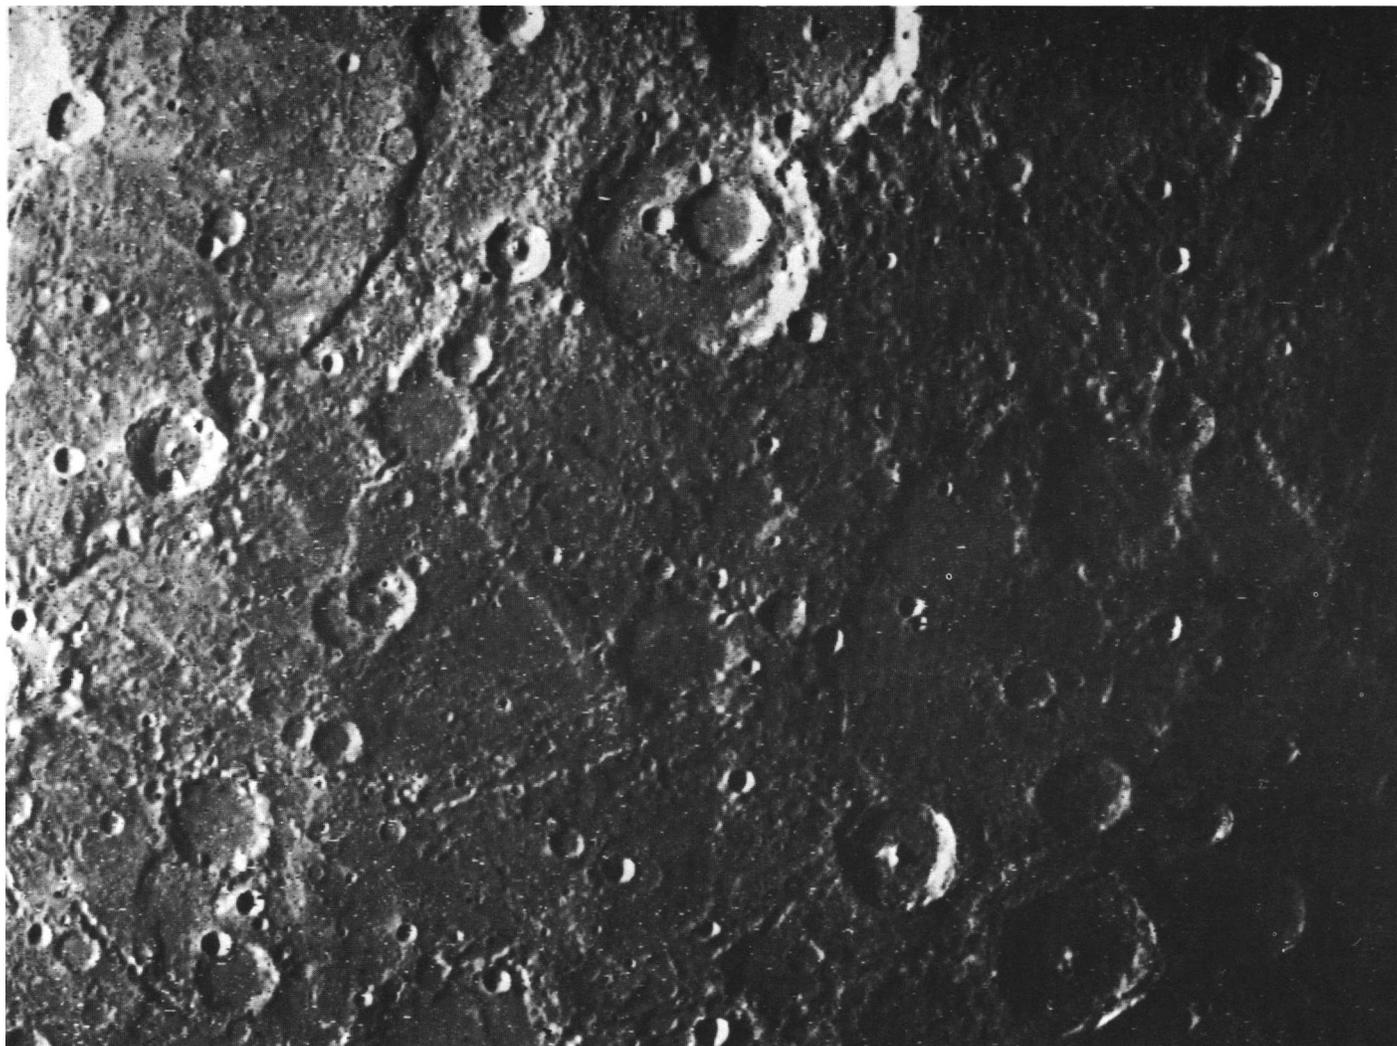
Mariner 10 obtained this picture of an area 460 by 640 kilometers (285 by 400 miles) in the Southern hemisphere of Mercury during its second encounter with the planet on September 21, 1974. Taken from a distance of 78,000 kilometers (48,000 miles), the photo reveals a heavily cratered terrain with a prominent scarp extending several hundred kilometers across the upper left. A 40-kilometer-diameter (25 miles) crater, nested in a larger crater, 120 kilometers (75 miles), is at top center. A basin about 240 kilometers (15 miles) in diameter is barely discernible at lower right. Crater chains produced by material ejected from a larger crater located outside the field of view appear at lower left. The smallest details detected measure about 1.7 kilometers (one mile).

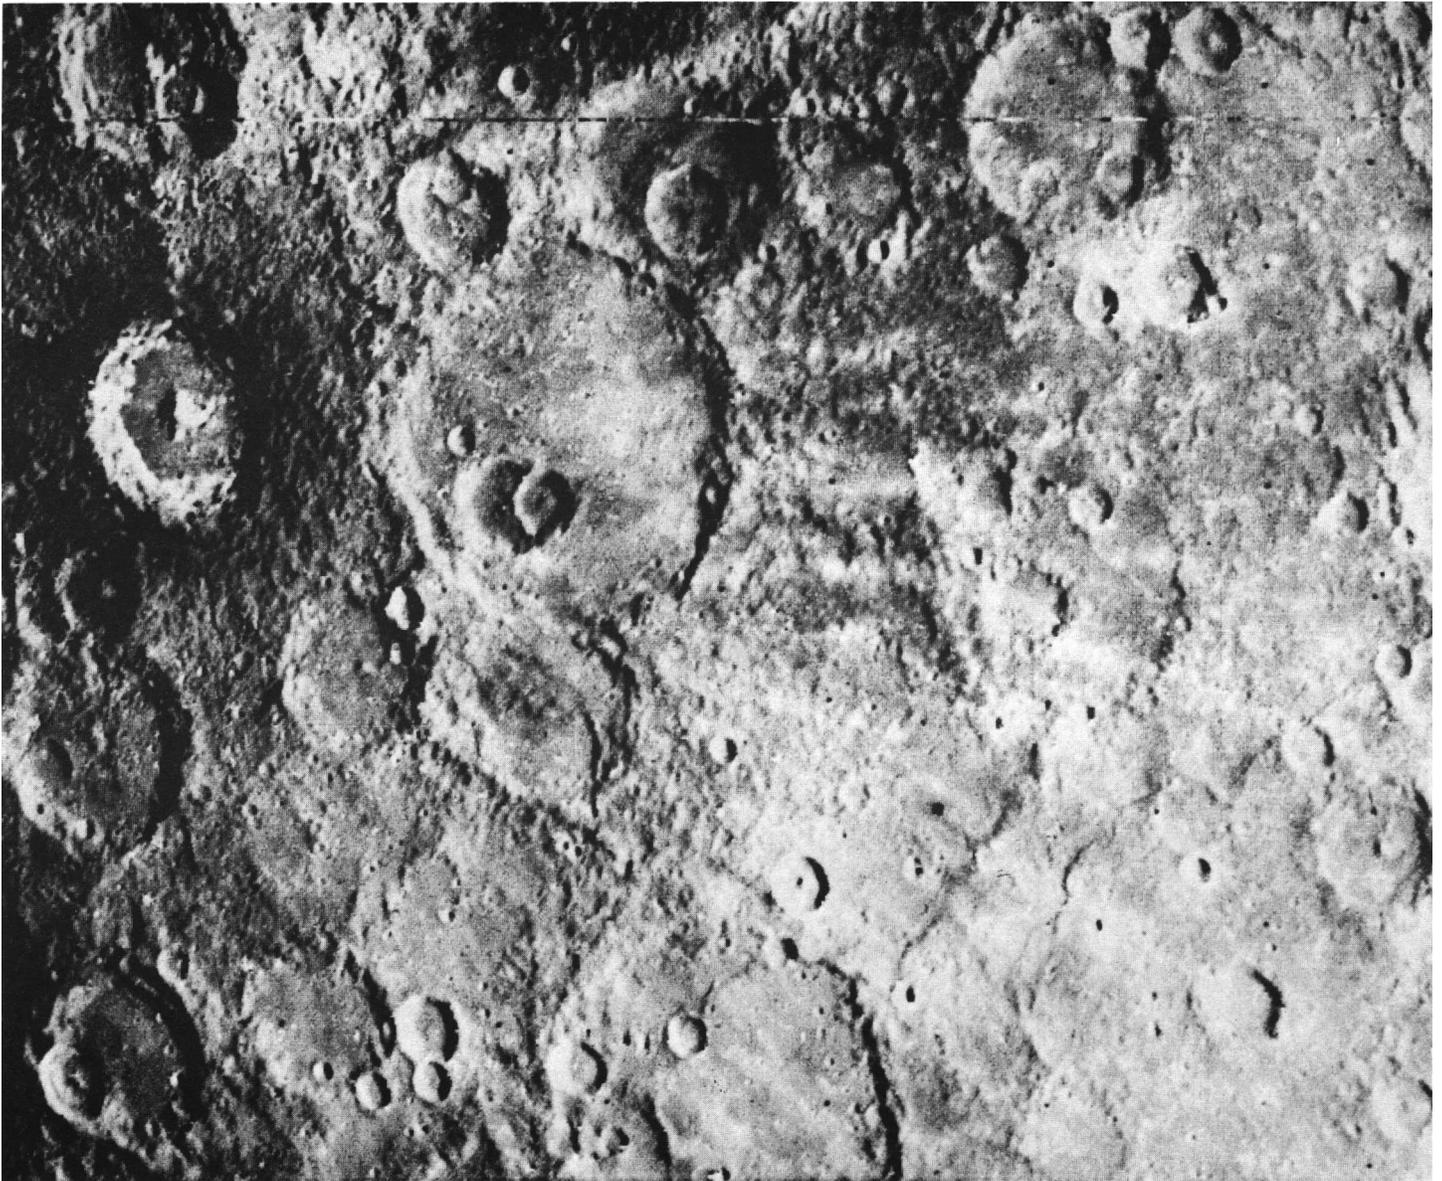
Mariner 10 took this picture from a distance of 63,400 kilometers (39,300 miles) about an hour after it passed under the south pole of Mercury. The dark-rimmed crater at upper left is 67 kilometers (42 miles) in diameter. It is surrounded by an extensive ejecta blanket and exhibits a bright ray pattern which extends into and beyond the larger crater (120 kilometers, 75 miles) to its right and near the picture's center. The dark-rimmed crater is similar to crater Tycho on Earth's moon. The center of this picture is located 33° S. Lat., 158° W. Long. North is to the top.

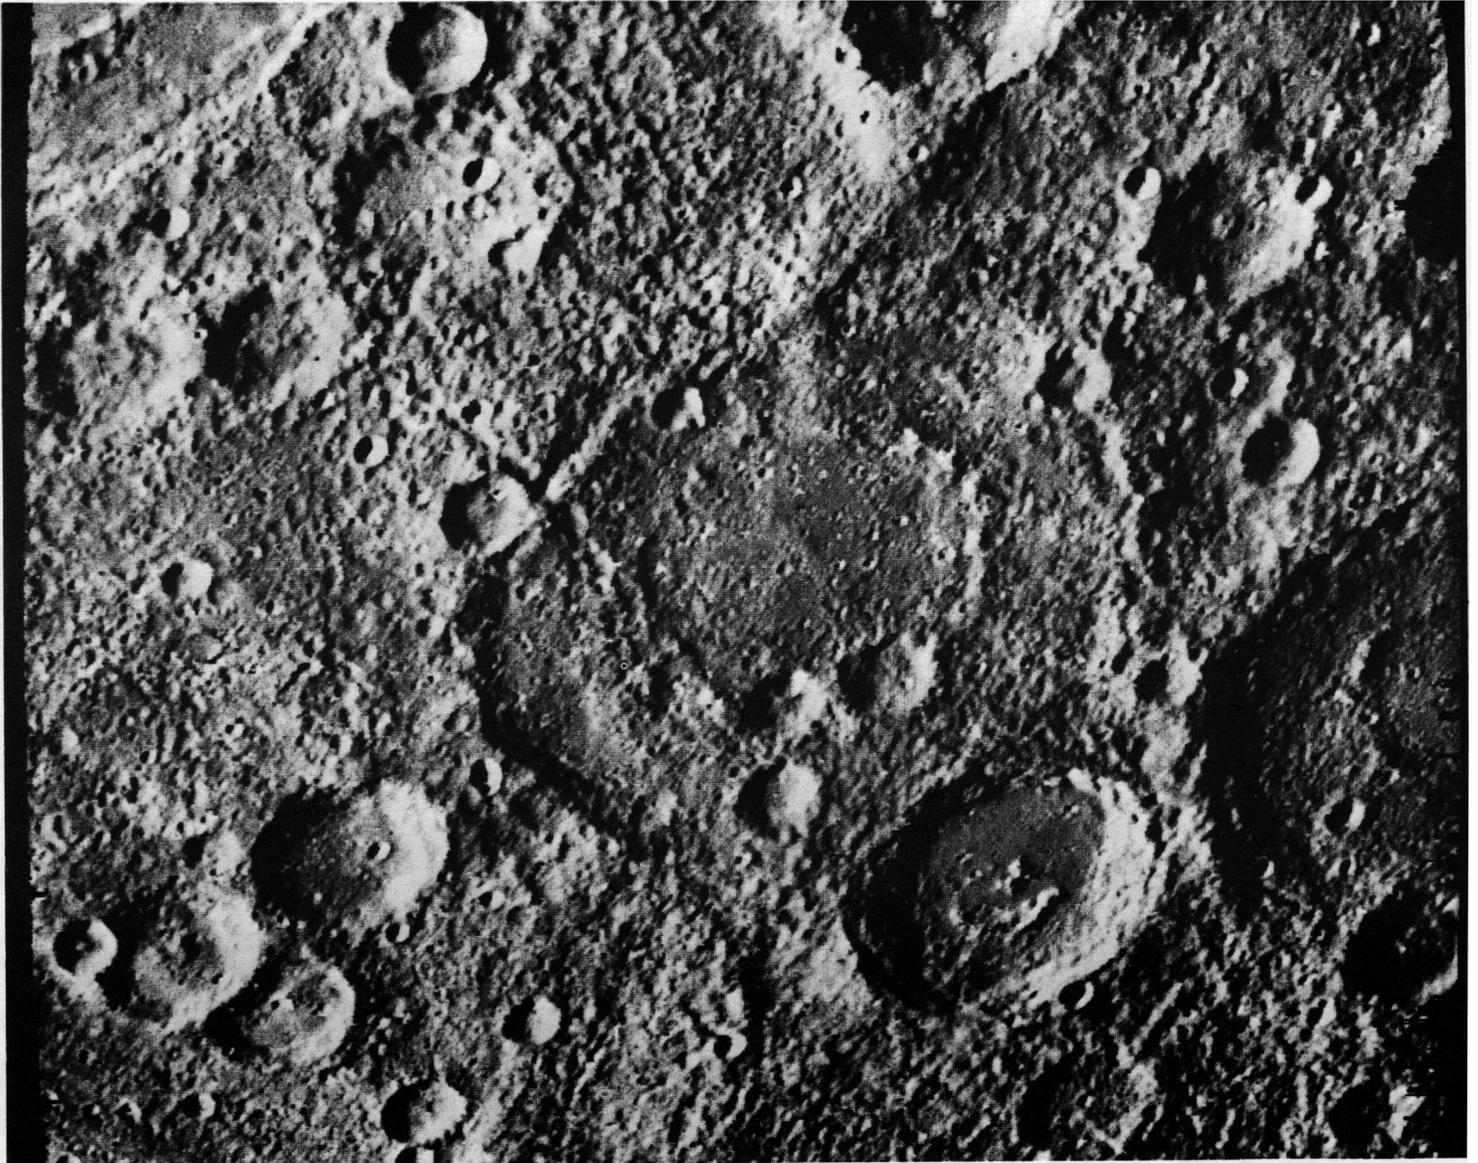
Taken about 40 minutes before Mariner 10 made its close approach to Mercury on September 21, this picture shows a large (230 kilometers, 142 miles) double-ringed basin (center of picture) located in the planet's south polar region —  $75^{\circ}$  S. Lat.,  $120^{\circ}$  W. Long. The basin was seen from a different viewing angle on Mariner 10's first sweep by Mercury last March. This picture was taken from about 55,000 kilometers (44,000 miles). North is toward upper left.
